ATTACHMENT B

VISUAL SITE ~~INSPECTION SUMMARY AND~~ PHOTOGRAPHS

FACILITY NAME: Union Carbide Corporation - Electronics Division
EPA I.D. NUMBER: OH0004167383
LOCATION CITY: Cleveland
STATE: Ohio

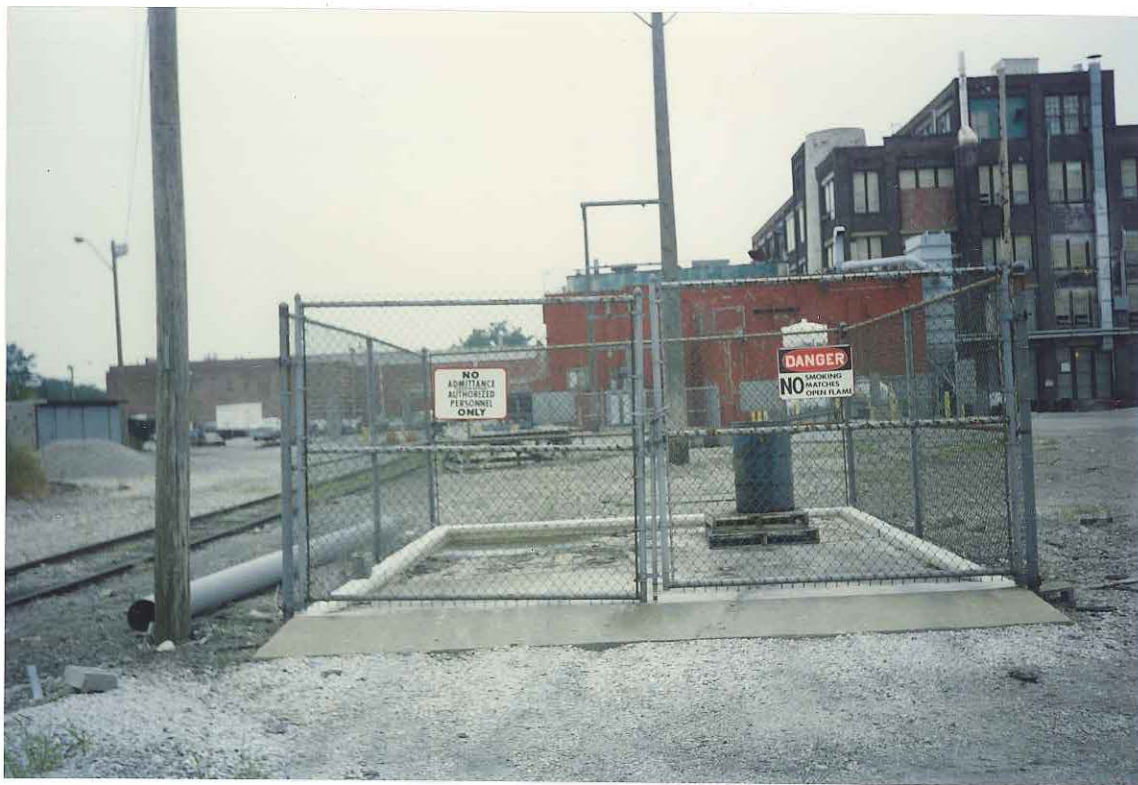
Photograph No. 1

Description: The pad is constructed of reinforced concrete and is surrounded by a 7-foot-high steel-wire fence, which is always locked. The pad also has a 4-inch-high concrete curbing.

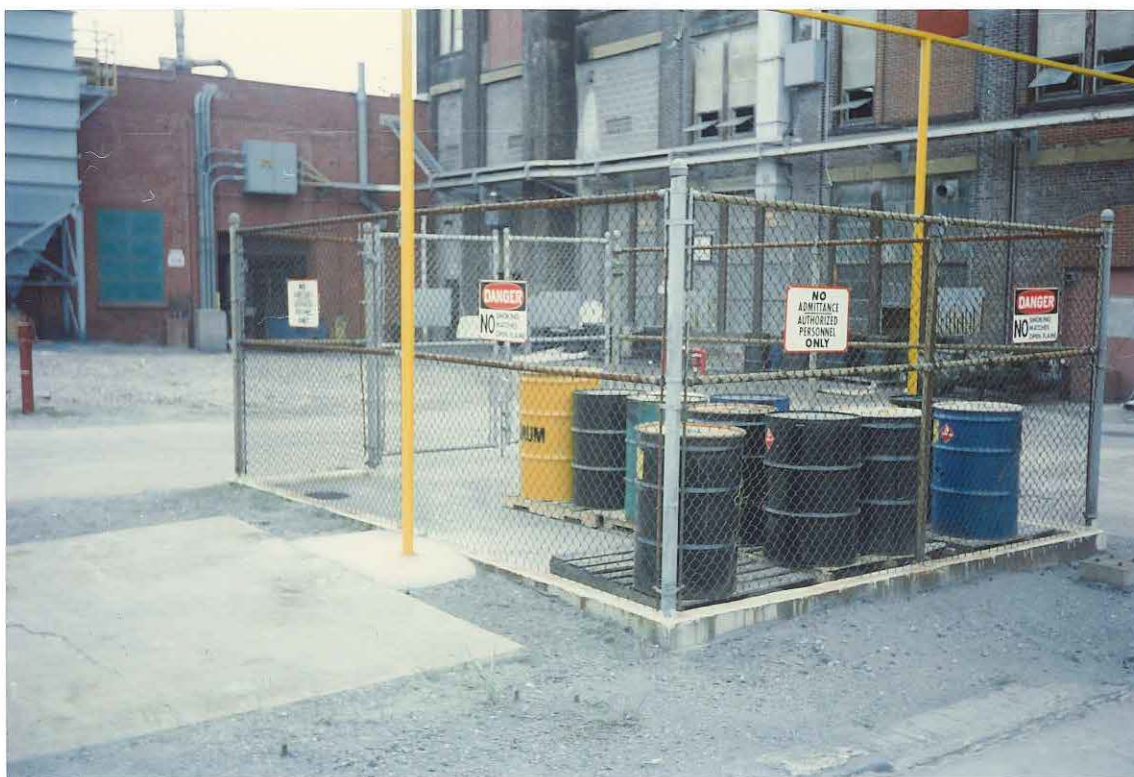
Photograph No. 2

Description: The pad is constructed of reinforced concrete and is surrounded by a 6-foot-high steel-wire fence, which is always locked. The pad also has a 4-inch-high concrete curbing.

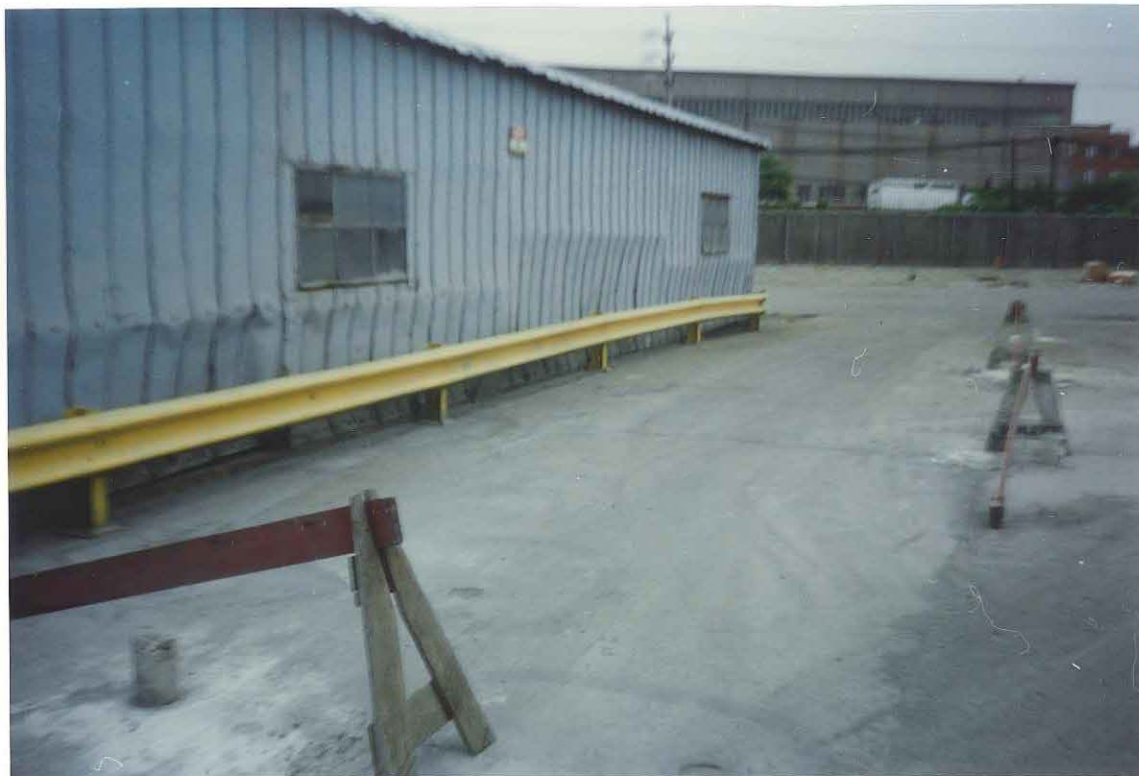
Photograph No. 3 **Location:** SWMU 3
Orientation: South **Date:** 06/25/91
Description: The former location of Pad C. The unit has not been used since 1982 and is a concrete pad with no curbing, containment, or fence.

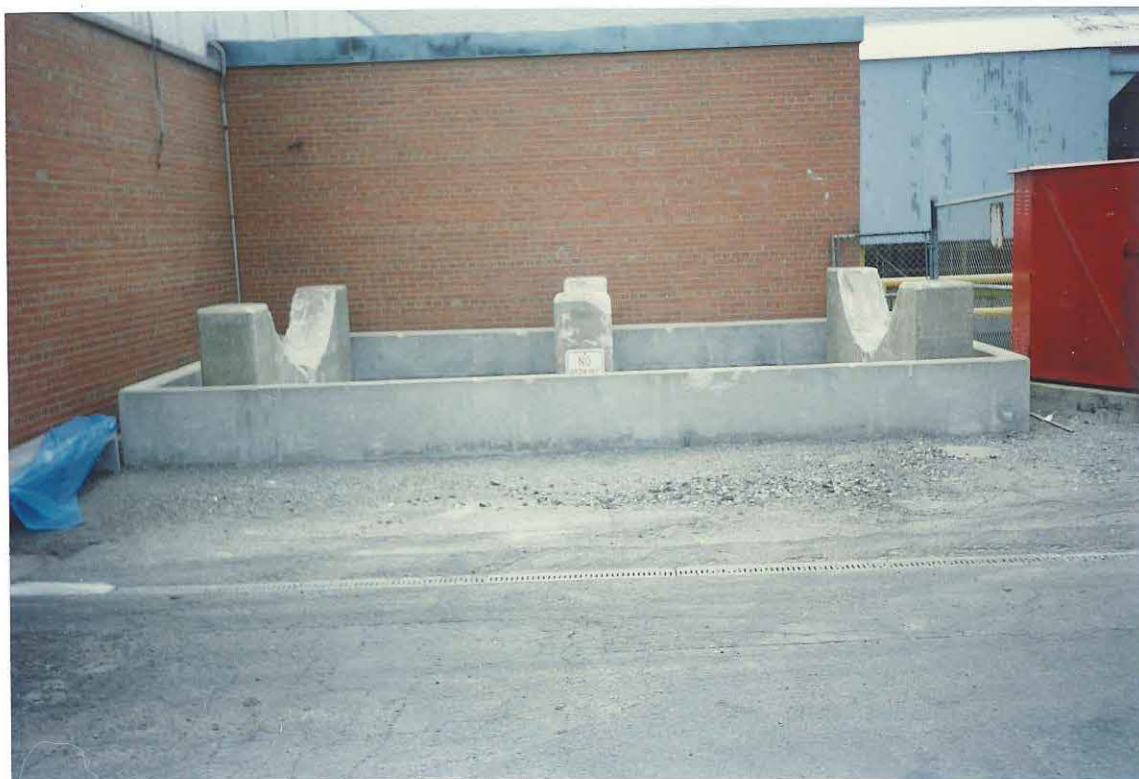
Photograph No. 4 **Location:** SWMU 4
Orientation: West **Date:** 06/25/91
Description: Former location of Tank D. The tank and its contents were removed in 1990. Currently on location are the concrete support columns for the tank. Building 7 is in the background.

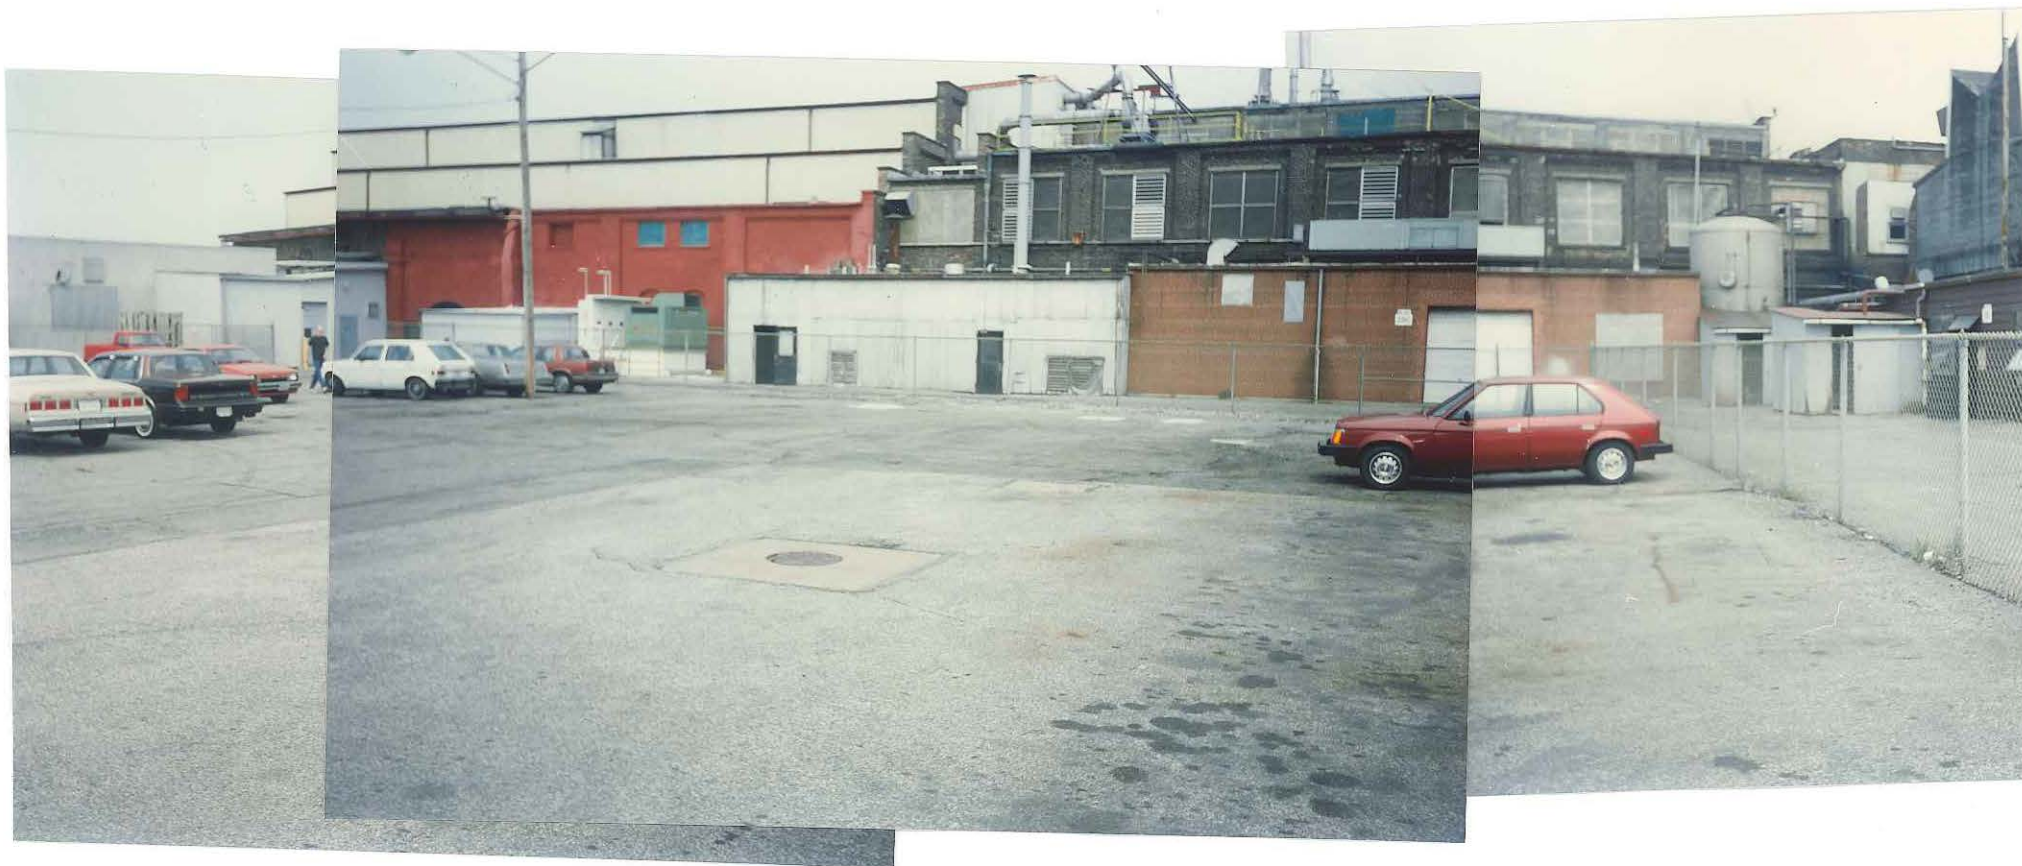
Photograph No. 5
Orientation: Southeast to northeast
Description: The flue area is currently a paved parking lot.

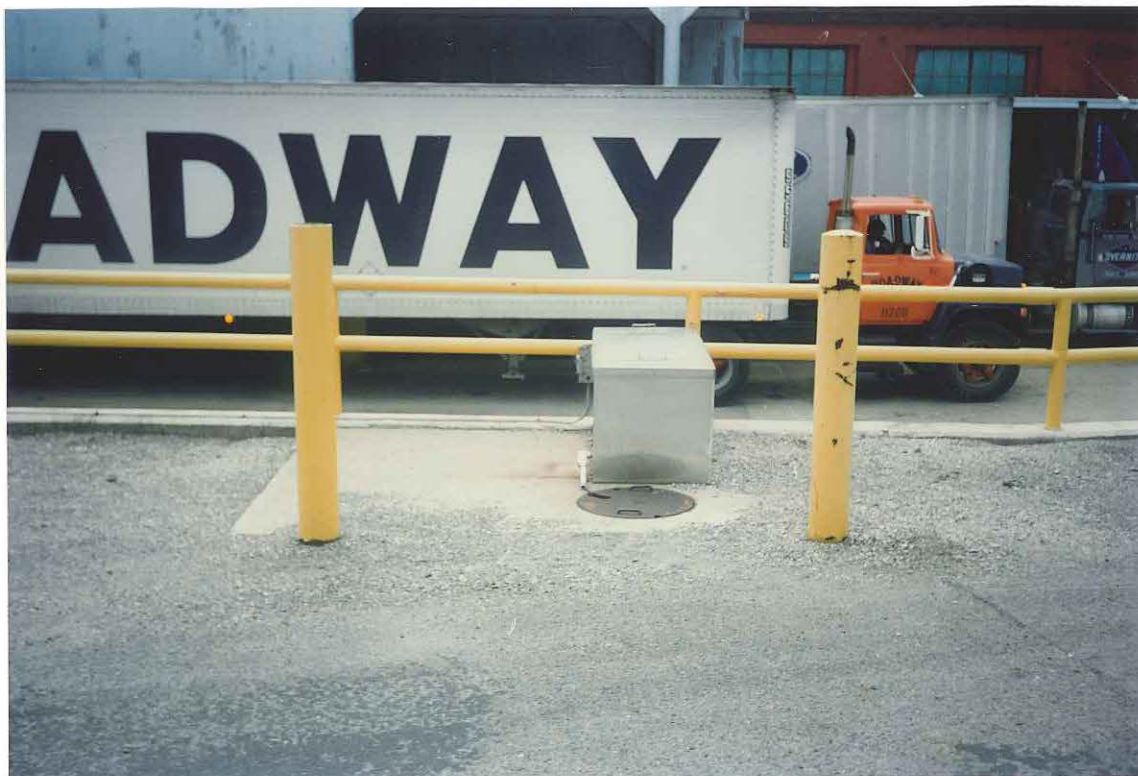
Photograph No. 6 **Location:** West of SWMU 5
Orientation: West **Date:** 06/25/91
Description: The sump system on the western side of the flue area (SWMU 5). The sump system is used to control any fluid accumulation in the flue area due to precipitation and surface water that infiltrated the surface of the parking lot.

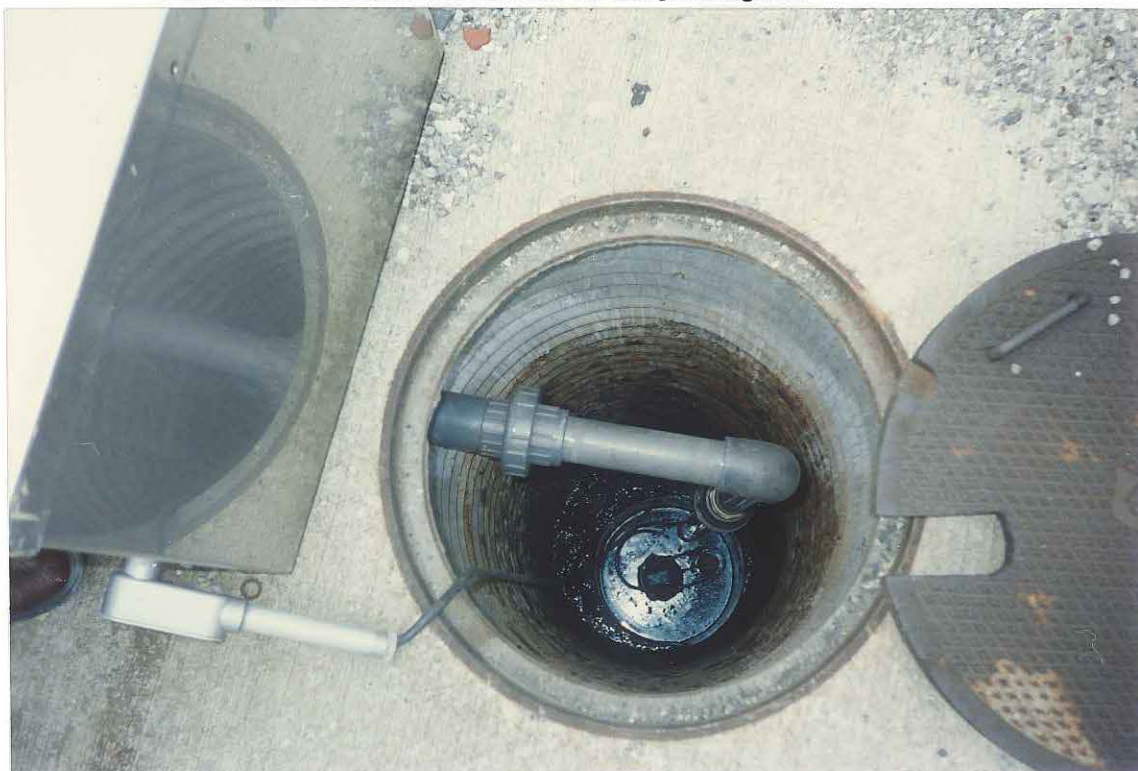
Photograph No. 7 **Location:** West of SWMU 5
Orientation: Inside the sump system **Date:** 06/25/91
Description: The 24-inch-diameter corrugated pipe inside the sump system. A 2-inch-diameter PVC pipe is located within the corrugated pipe and discharges the collected liquid to the sanitary sewer. A pump with a float trigger draws the liquid out of the sump when the fluid reaches a certain level with the corrugated pipe.

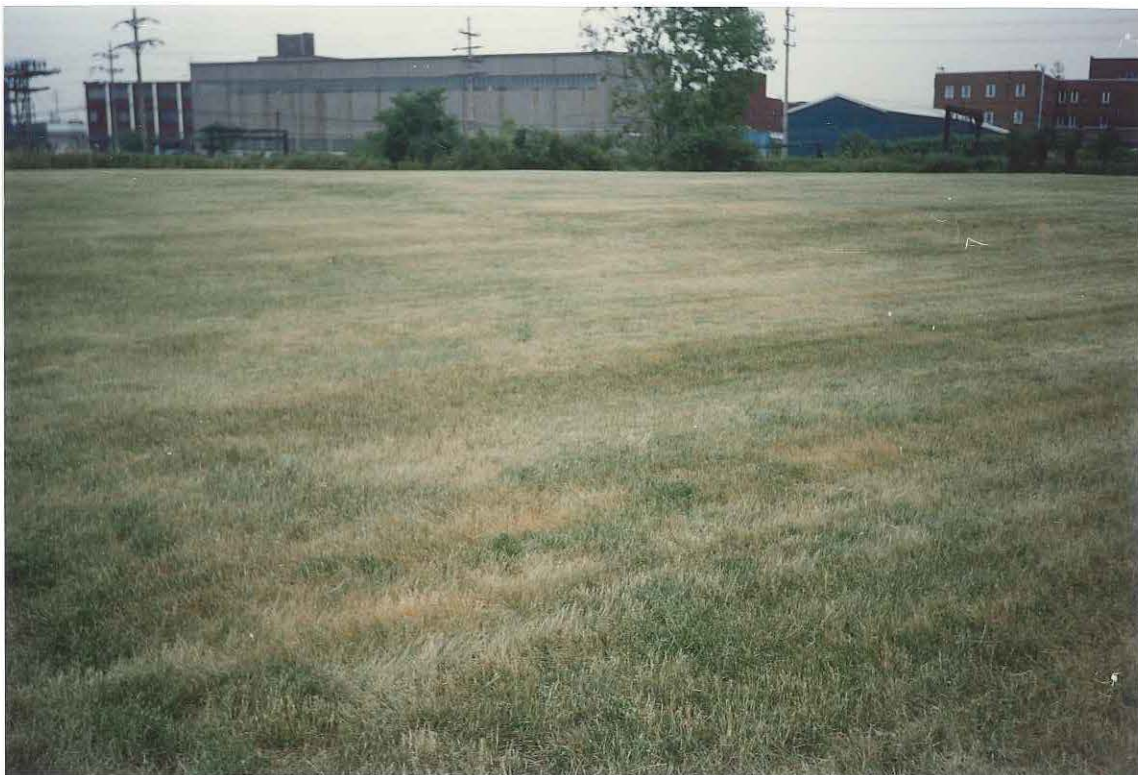
Photograph No. 8 **Location:** SWMU 6
Orientation: Southeast **Date:** 06/25/91
Description: The former landfill area is graded and covered with grass. No stress vegetation is observed.

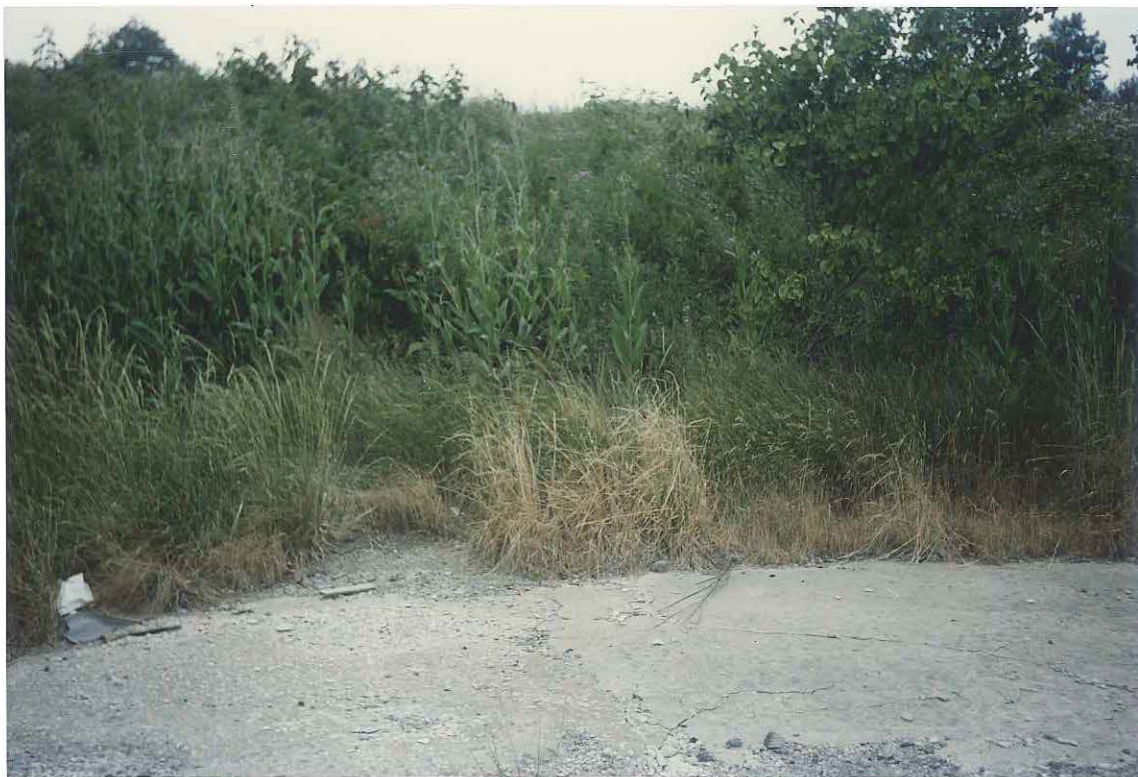
Photograph No. 9 **Location:** SWMU 7
Orientation: West **Date:** 06/25/91
Description: Part of the incinerator area is covered with vegetation and part of the area is on barren ground. The former landfill area (SWMU 6) is in the background.

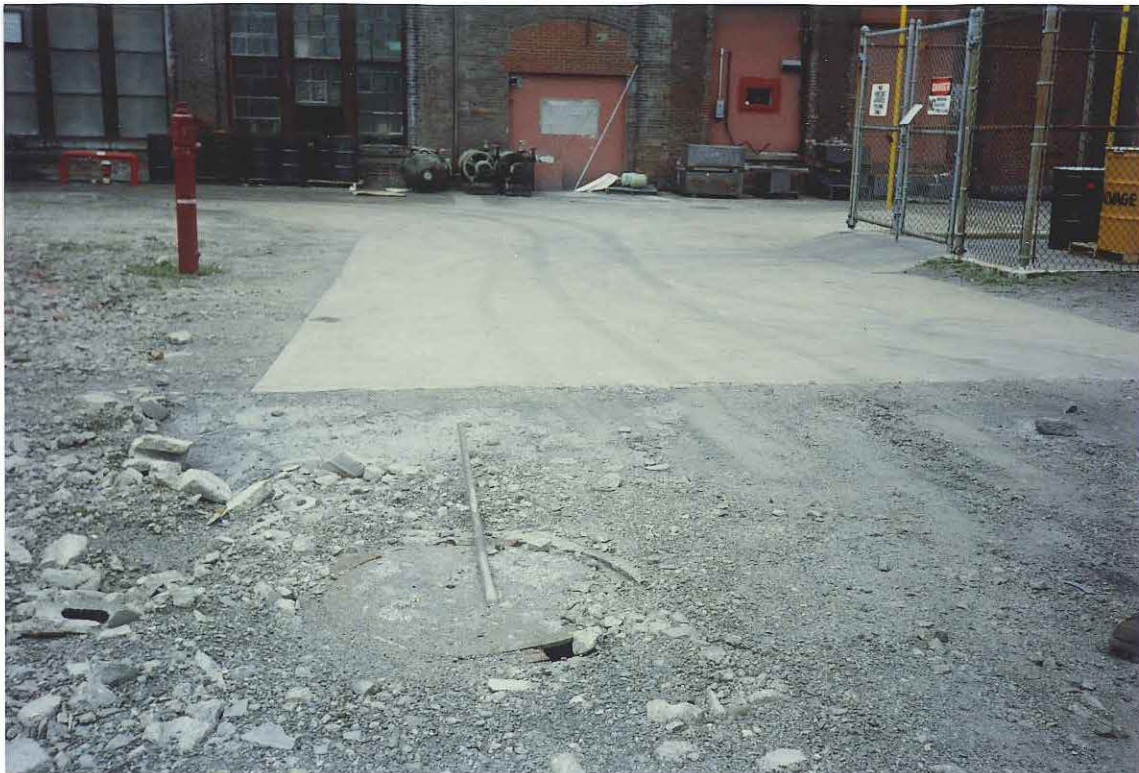
Photograph No. 10

Description: Beneath the chute in the foreground is the concrete vault (SWMU 8) that stored the boron nitride particulates from the boron nitride process. Hazardous waste storage Pad B is in the upper right-hand corner of the photo.

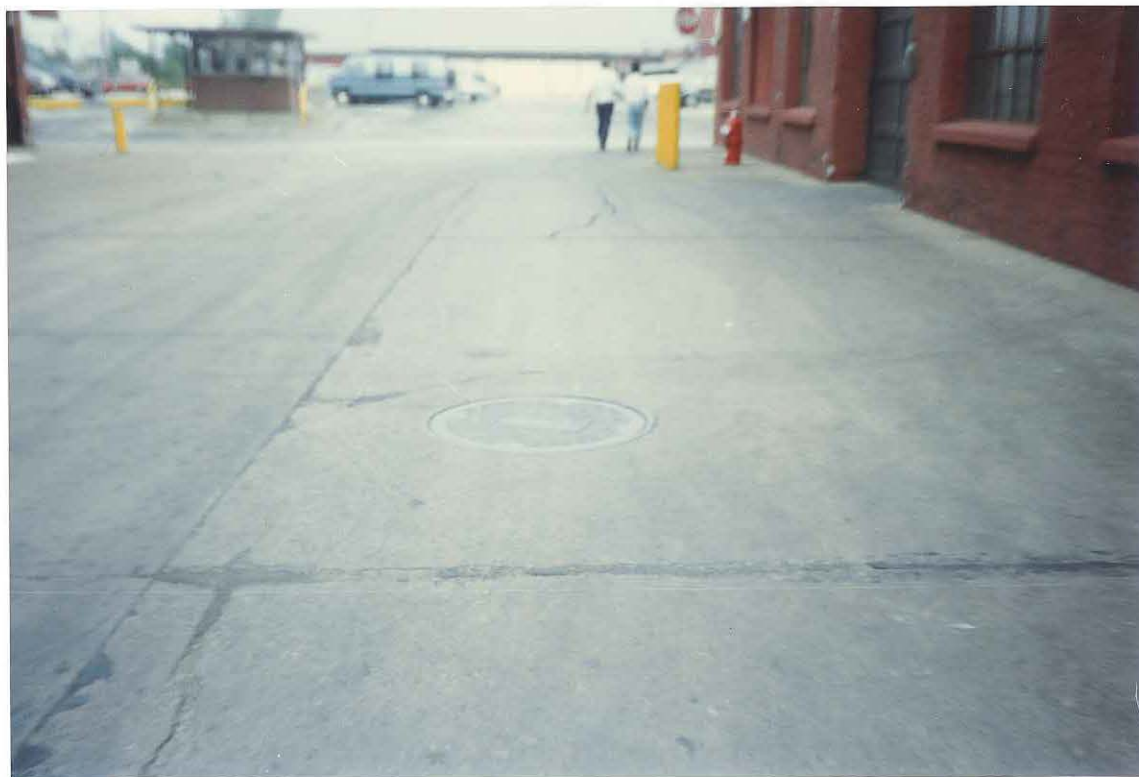
Photograph No. 11

Description: Beneath the steel lid is the concrete vault (SWMU 9) that stored the graphite and carbon dust from the wet machining process.

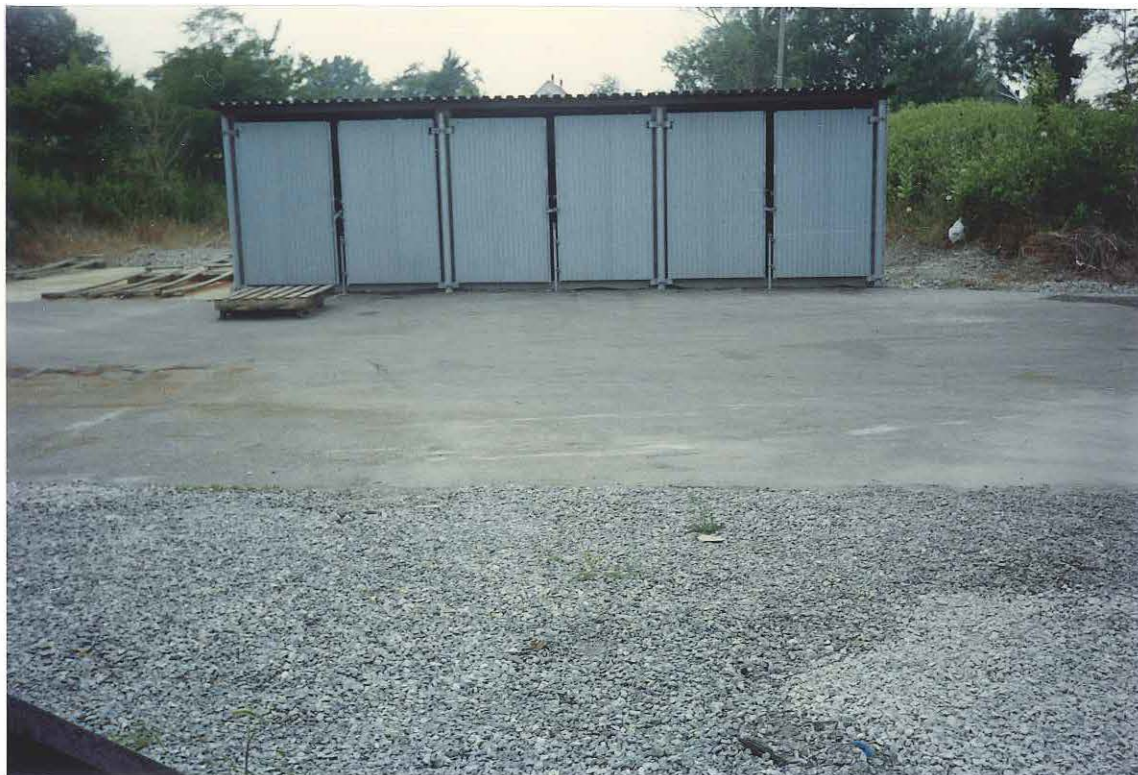
Photograph No. 12

The former used oil and empty drum storage area is on a concrete pad, surrounded by three brick walls and covered by a metal sheet. The whole area is separated into three smaller areas by two brick walls. Each area has two metal doors and has a 4-inch curbing. The former landfill area (SWMU 6) is at the back. The area is used to store raw materials.

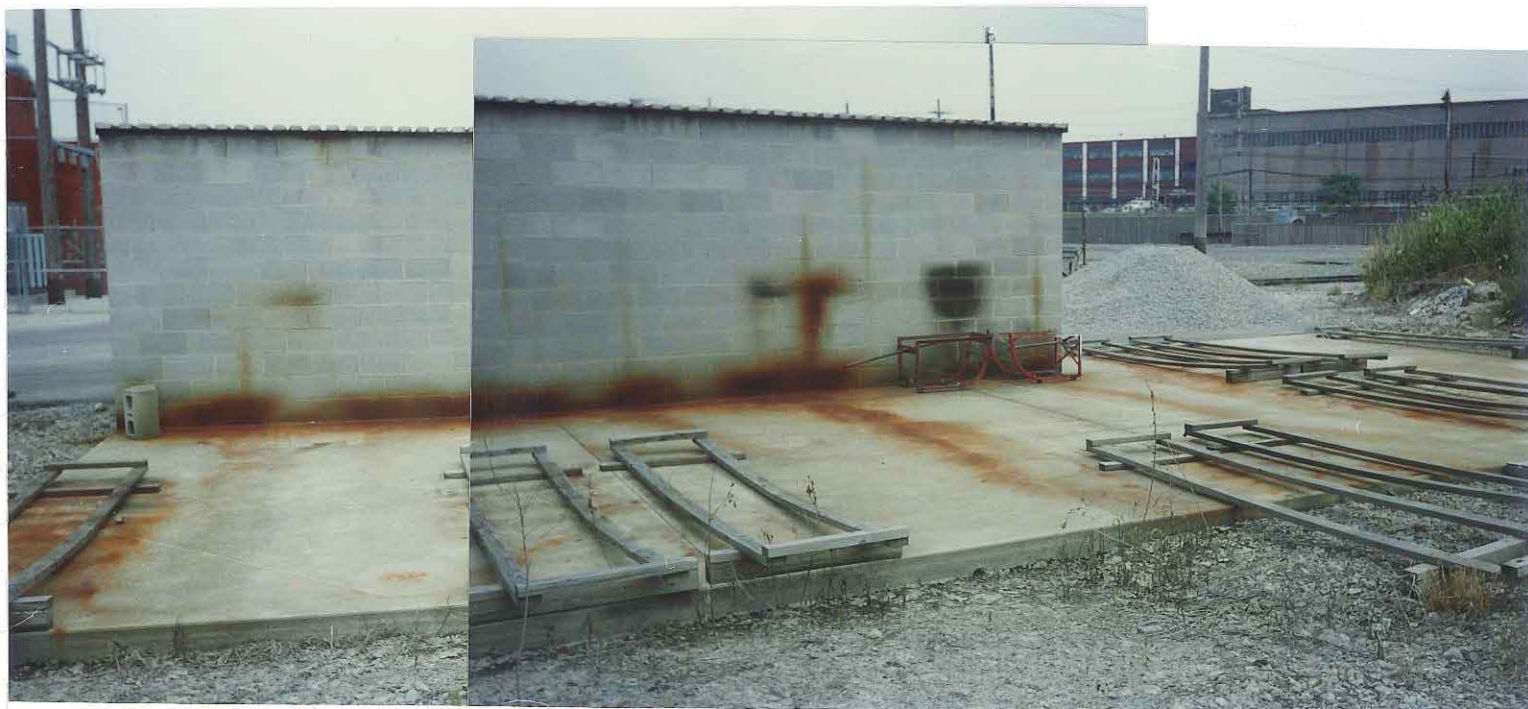
Photograph No. 13

The back side of the former oil and empty drum storage area.

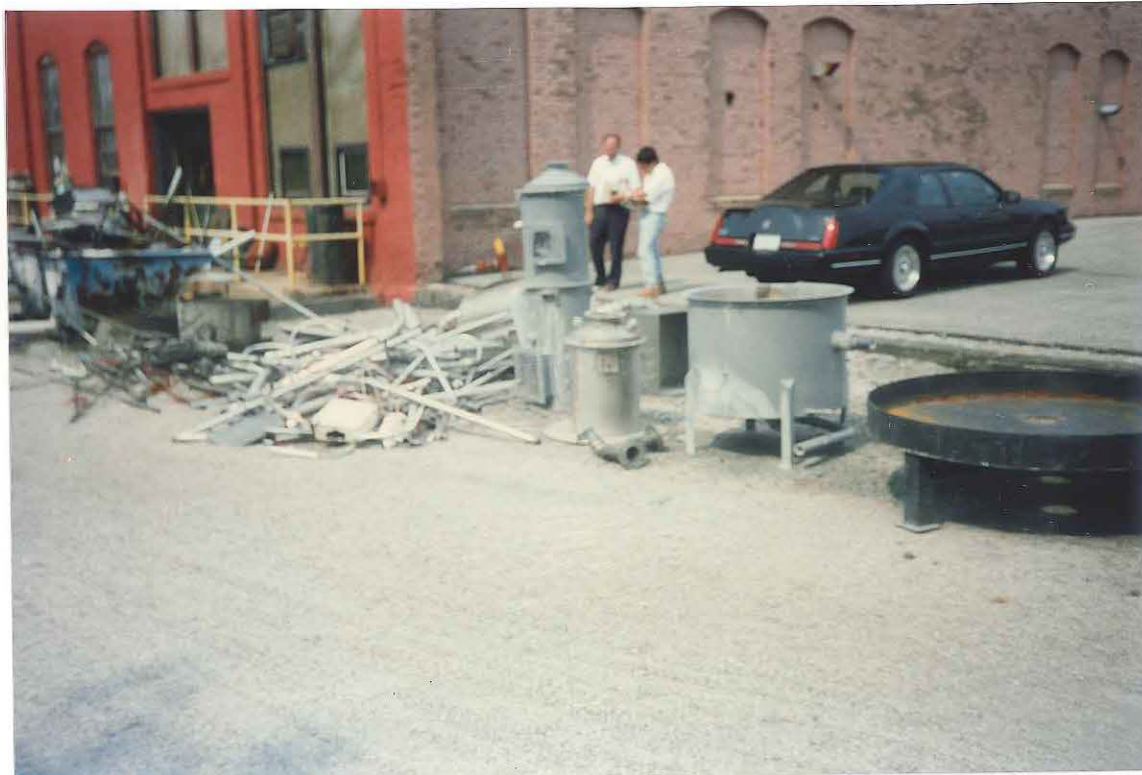
Photograph No. 14 **Location:** SWMU 11
Orientation: North **Date:** 06/25/91
Description: Scrap metals from various activities in the facility pile up on barren ground.

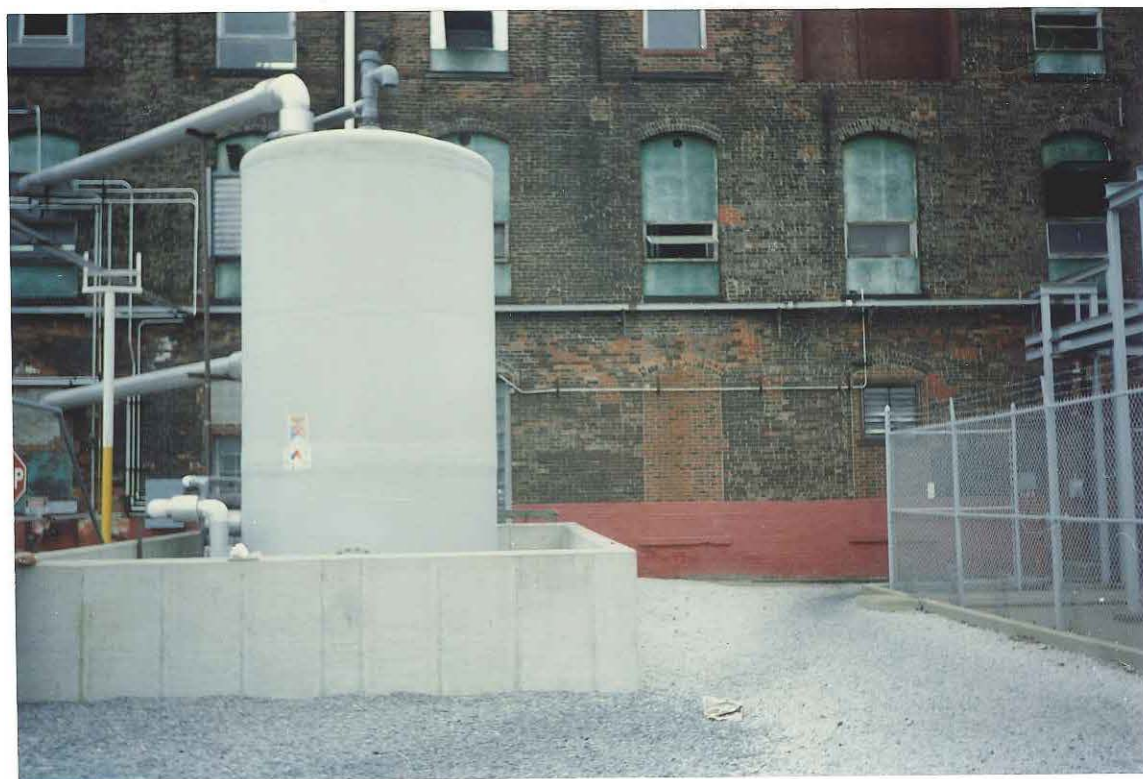
Photograph No. 15 **Location:** SWMU 12
Orientation: East **Date:** 06/25/91
Description: Tank 1 (10,000 gallons) of the Grafoil process neutralization system. The tank is on a concrete floor surrounded by concrete walls. Building 10 is in the background.

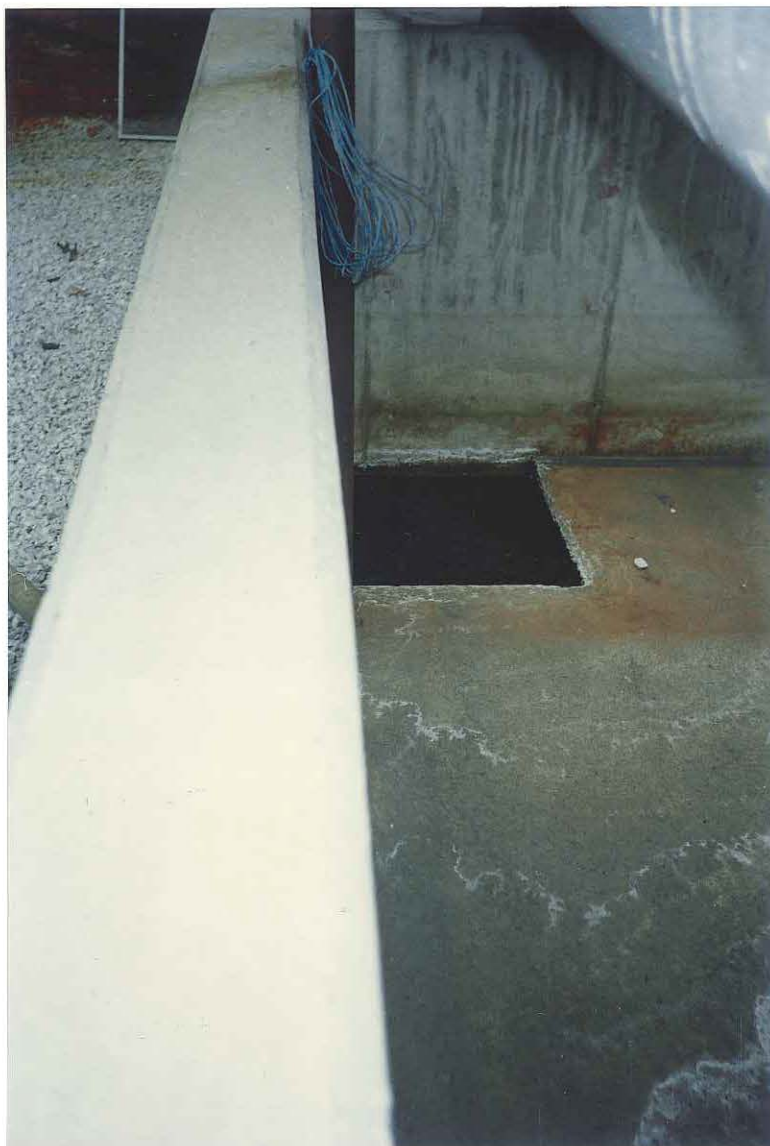
The sump for the first tank of the Grafoil process neutralization system. It is located in the northeastern corner inside the concrete wall for the tank.

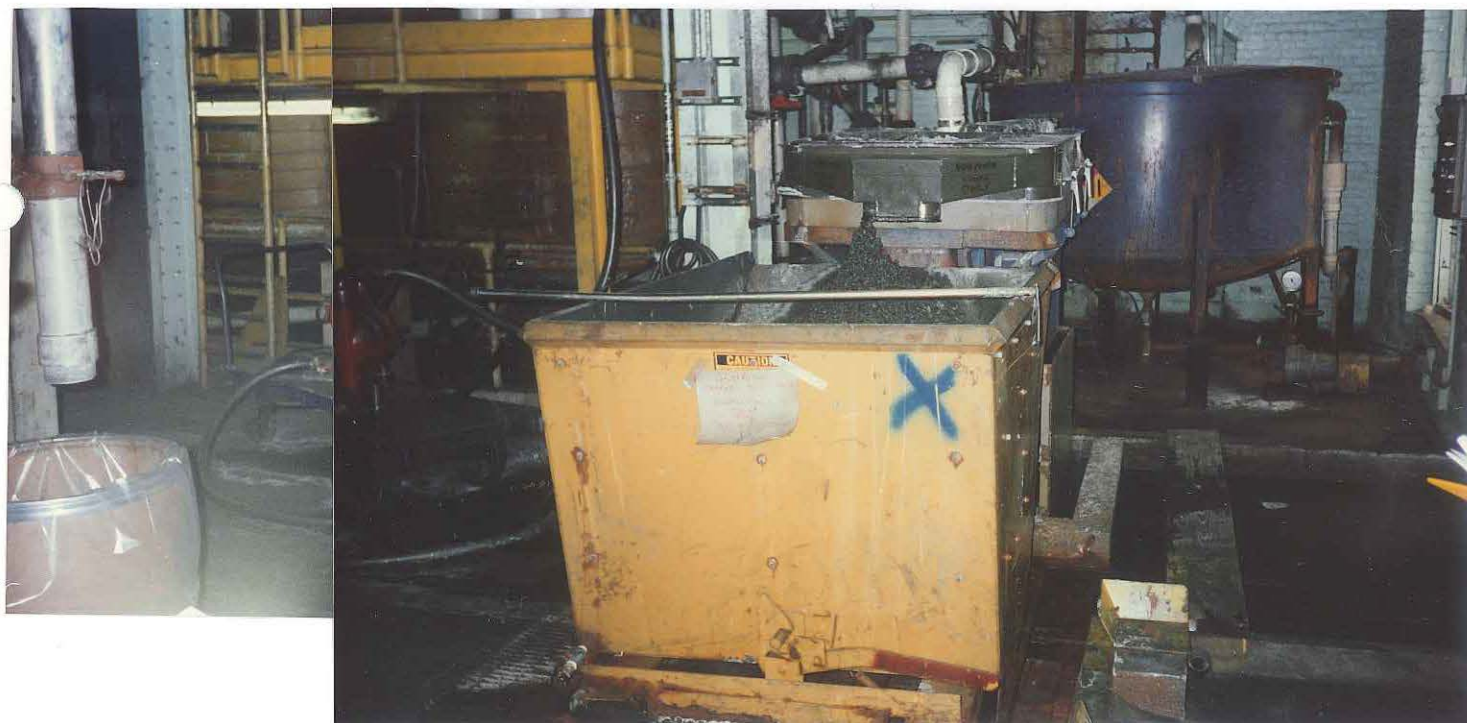
Photograph No. 17

Description: The yellow hopper in the foreground collects the sludge from the neutralization tanks. The sludge is then moved to the landfill hopper (SWMU) before being hauled offsite to a landfill. Neutralization tanks 2 and 3 are in the background to the right.

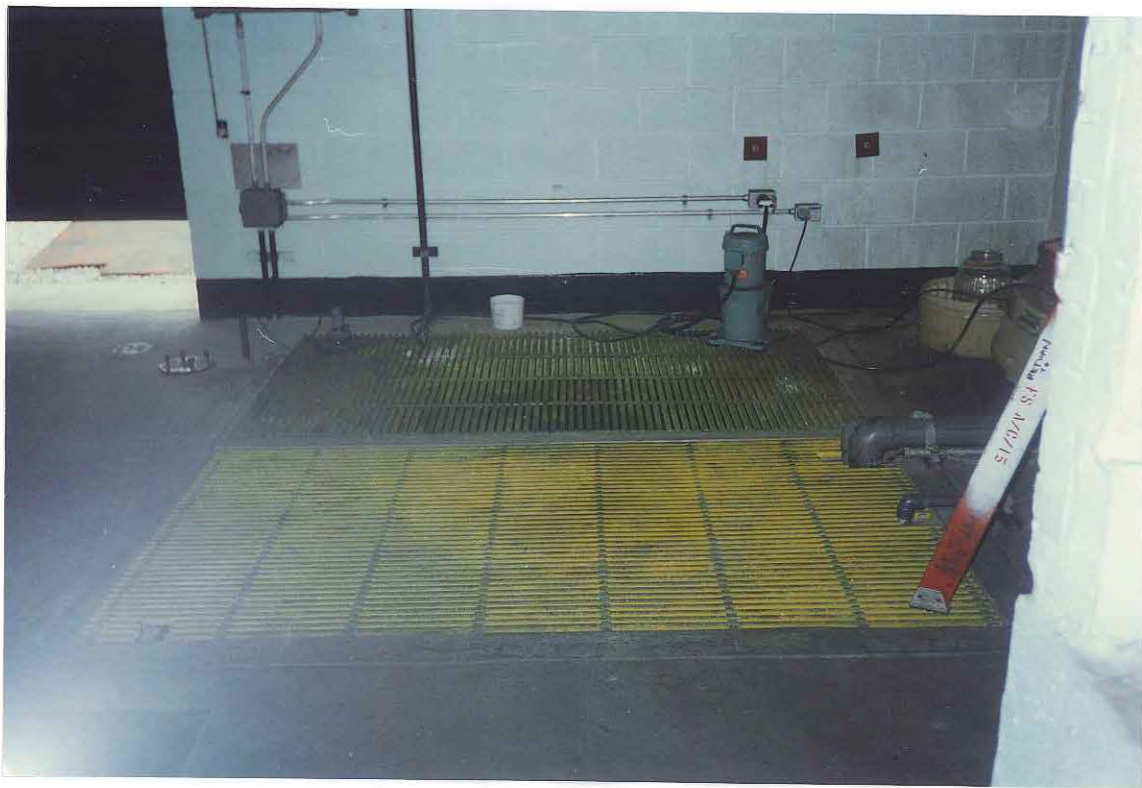
Photograph No. 19 **Location:** SWMU 14
Orientation: West **Date:** 06/25/91
Description: Beneath the steel gratings are tanks 2 and 3. Wastewater from tank 3 flows to the sewage.

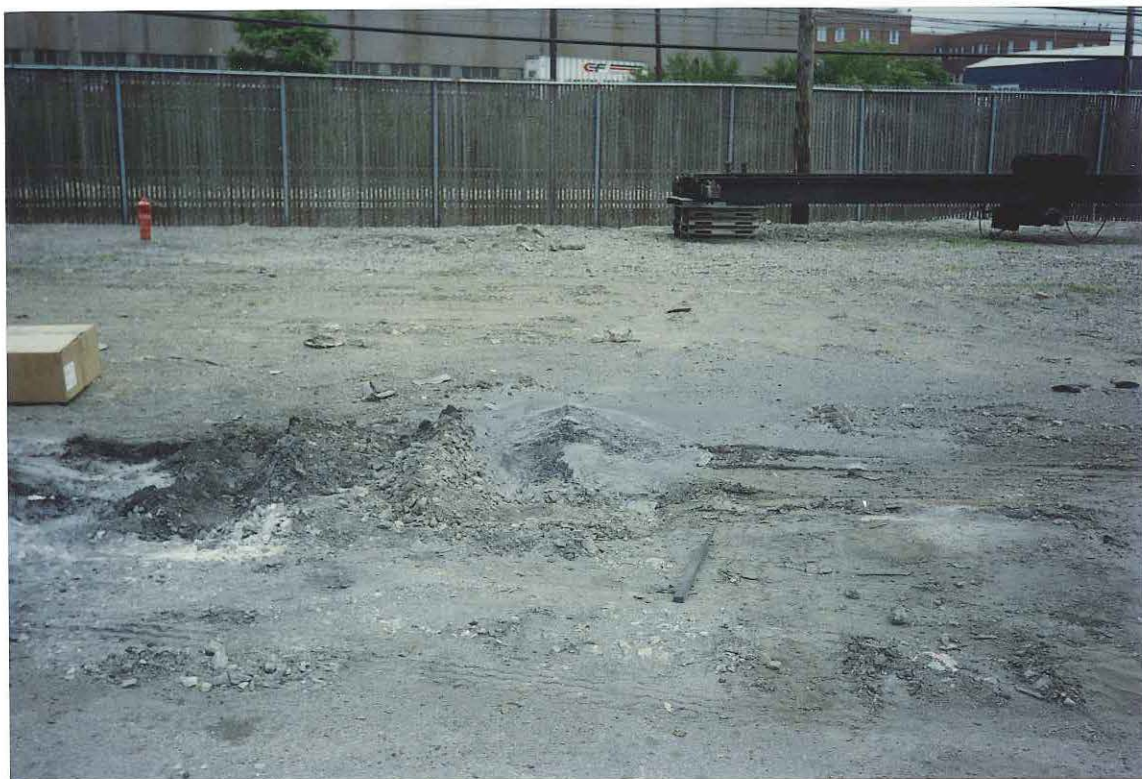
Photograph No. 20 **Location:** SWMU 15
Orientation: South **Date:** 06/25/91
Description: The area where the landfill hopper is located. The landfill hopper was not onsite during the PA/VSI. Graphite flakes were observed on the ground.

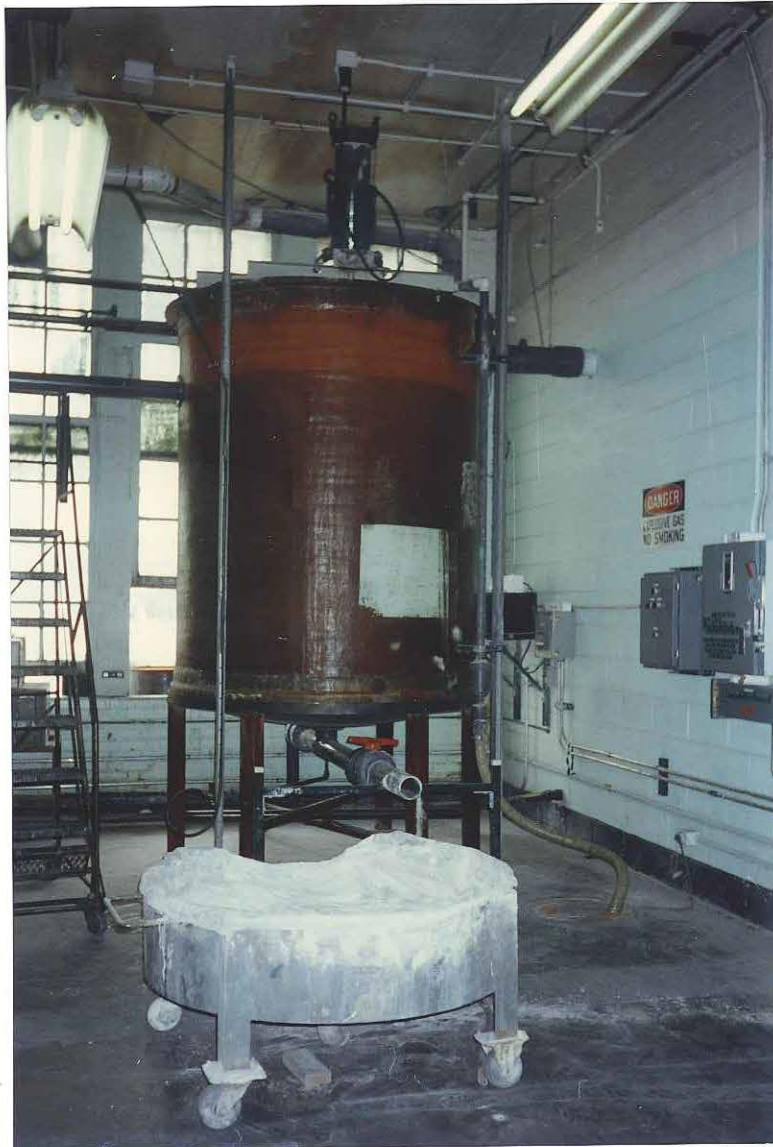
Photograph No. 21

The tank is located on a concrete floor on the ground floor of Building 10. The 1,100-gallon tank is made of fiberglass. In the foreground is a cart that collects the sludge from the neutralization tank. The sludge is moved to the landfill hopper (SWMU 15) before it is hauled offsite to a landfill. On the wall on the right is a pH meter that monitors the wastewater before it is discharged to the sewage.

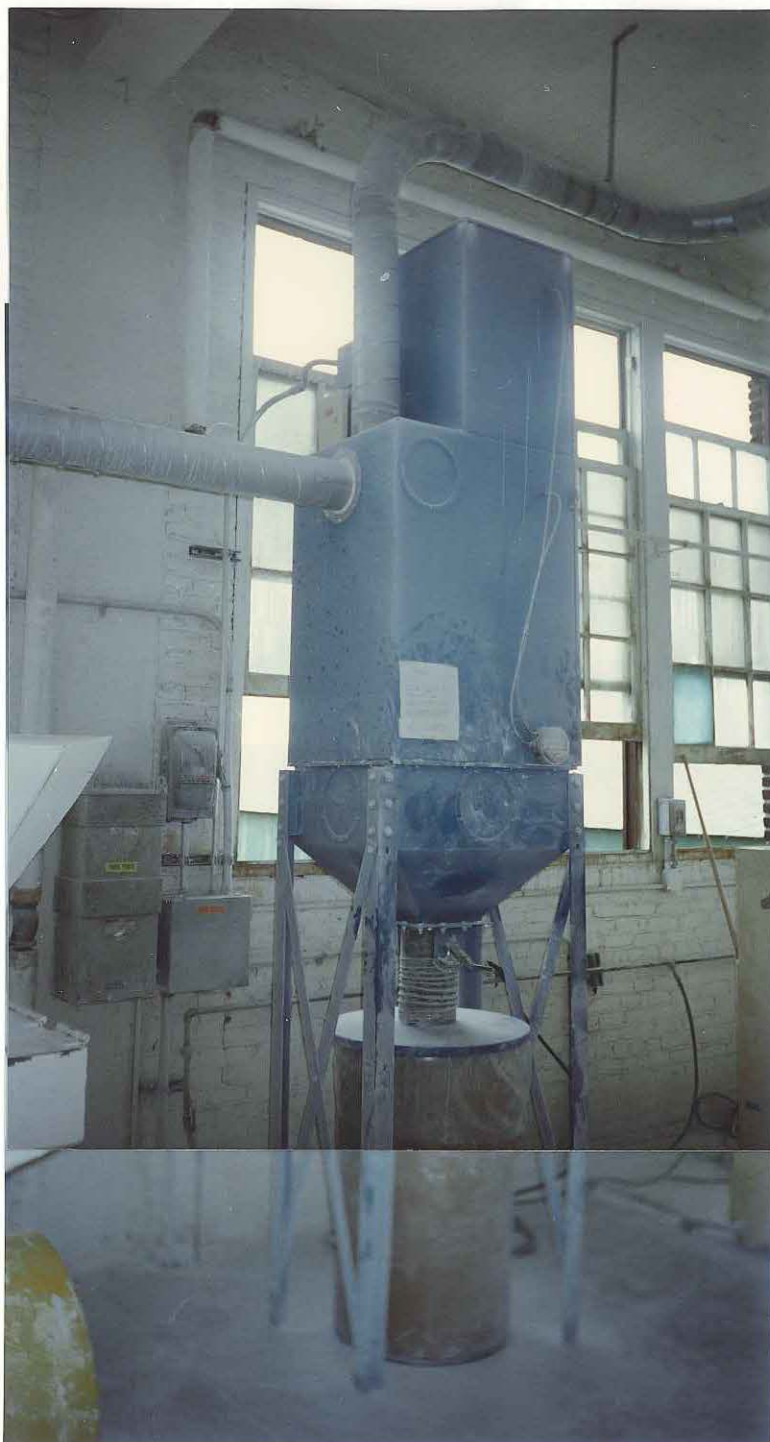
Photograph No. 22

One of the 12 dust collectors for the boron nitride process. This dust collector is located on the fourth floor of Building 10. The dust collected in the drums under dust collectors may be for recycle, or may be moved to the landfill hopper (SWMU 15) to be disposed offsite.

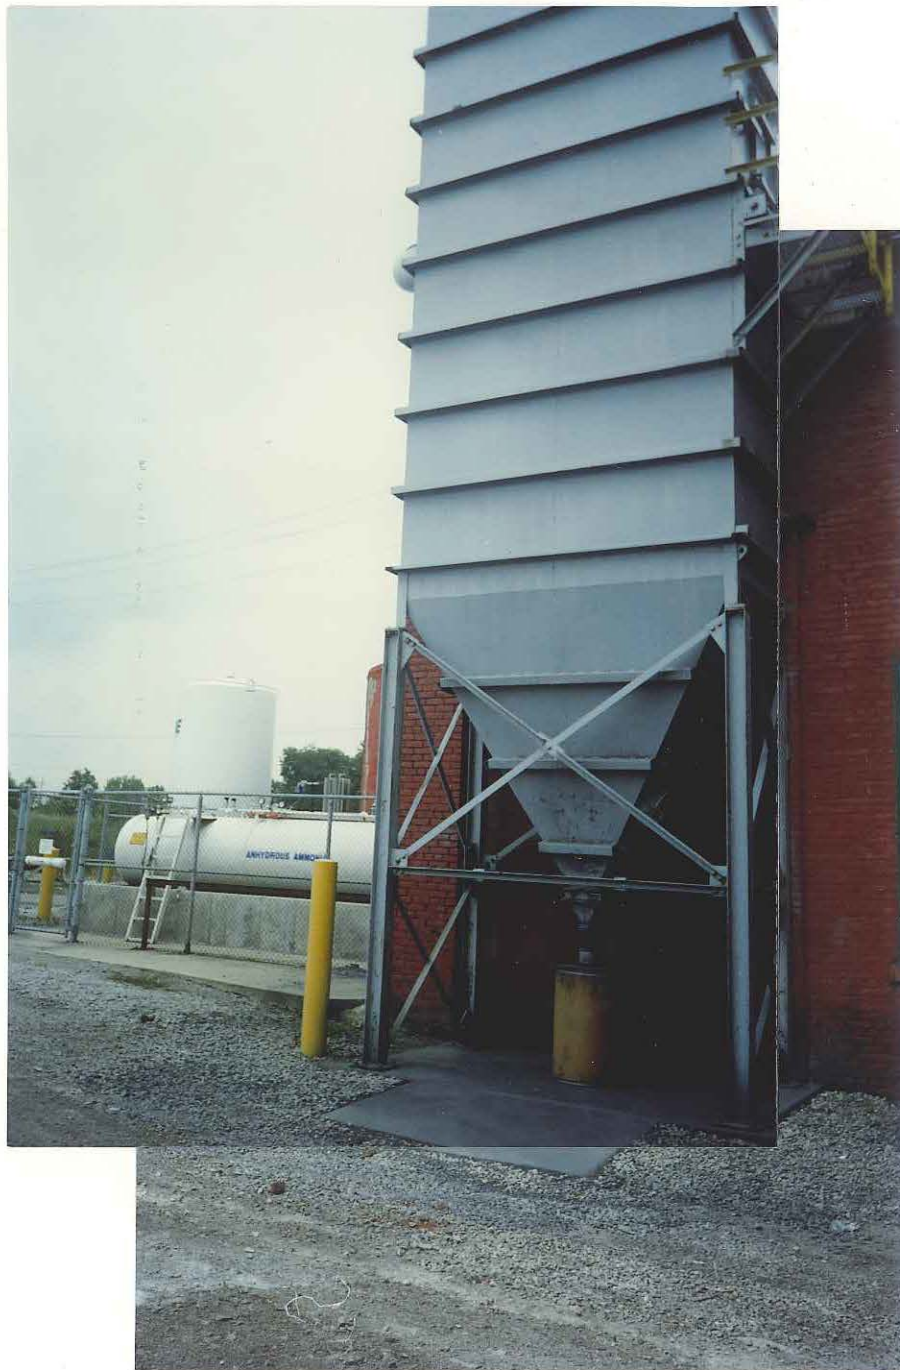
Photograph No. 23

Description: Dust collector for the intermetallic boron nitride process. The drum under the dust collector is on a concrete pad, and the dust is moved to the landfill hopper (SWMU 15) for disposal.
